TITLE Anode experiment 6 months		
AUTHOR		
DATE	nov 08	SHEET 1 OF 1
REVISION

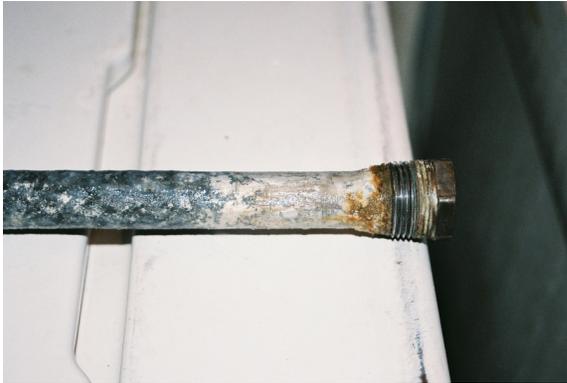
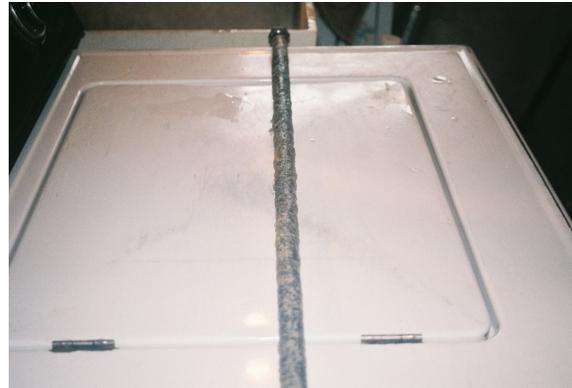
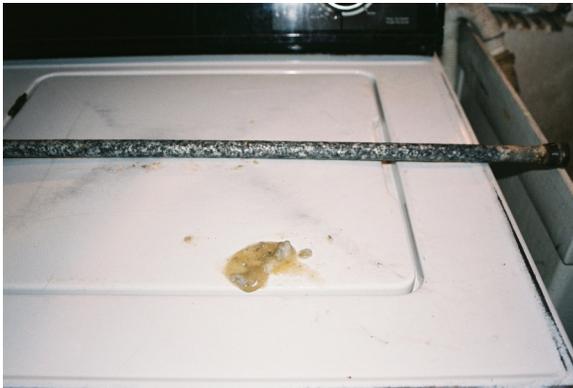
6 Month inspection shows continued deterioration of the anode rod.
The tank itself shows no added signs of corrosion even at the bi-metal connections.
